Navajo Abandoned Uranium Mine

Site Screen Report

Rattlesnake No. 8 AUM Site

August 2010

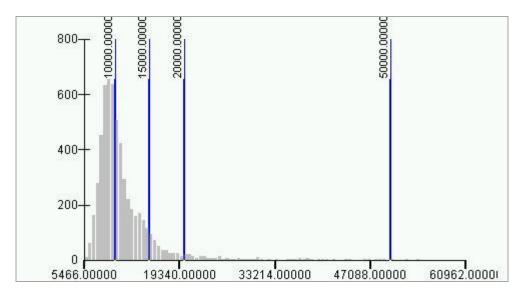
Distribution Chart and Statistics:

The following chart and statistics were generated by ESRI ArcGIS 9.3.1, and show the general distribution of the site gamma radiation measurements. The horizontal X axis represents the gamma radiation reading levels in cpm (lowest levels to the left). The vertical Y axis represents the frequency of each gamma radiation level.

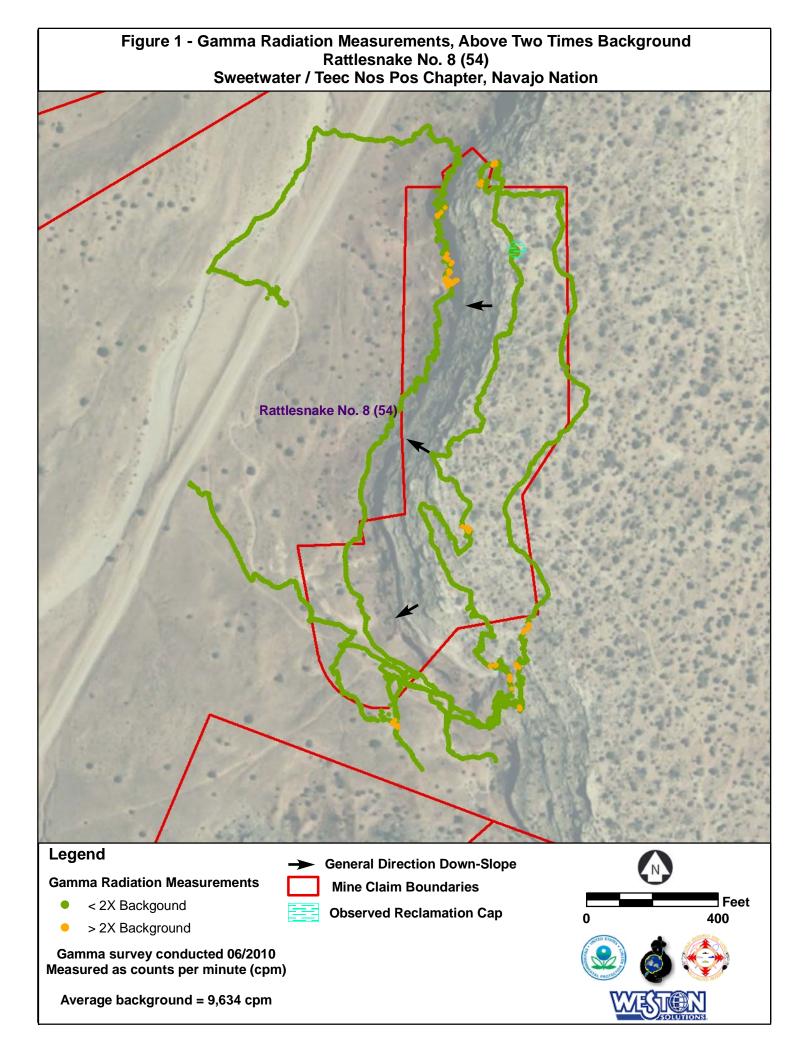
A total of 5,783 gamma radiation measurements were collected from the mine site, ranging from 5,466 cpm to 60,962 cpm. The measurements are represented in Figures 1 and 2.

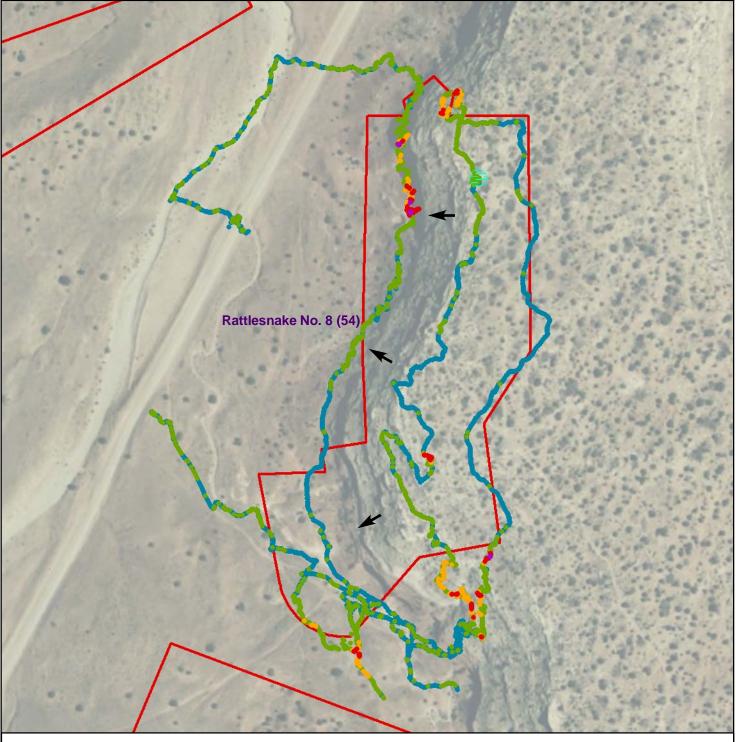
Figure 2 - Gamma Radiation Measurements Rattlesnake No. 8 (54) Sweetwater / Teec Nos Pos Chapter, Navajo Nation

Gamma survey conducted 06/2010 Measured as counts per minute (cpm)

Average background 9,634 cpm
